DECISION, FINDINGS OF FACT AND CONCLUSIONARY FINDINGS OF THE MCMINNVILLE HISTORIC LANDMARKS COMMITTEE FOR THE APPROVAL OF ALTERATIONS TO A HISTORIC LANDMARK LOCATED AT 835 NW BIRCH STREET

- DOCKET:** HL 3-20 (Certificate of Approval for Alteration)
- REQUEST:** Approval of alterations to an existing historic landmark and building that is listed on the McMinnville Historic Resources Inventory as a “Significant” historic resource (resource number B274). The proposed alterations include the relocation of one existing vinyl window, the addition of one new vinyl window, and the replacement of the existing asphalt composition roof with a standing seam metal roof.

- LOCATION:** 835 NW Birch Street. The property identified as Tax Lot 9300, Section 20AA, T. 4 S., R. 4 W., W.M.
- ZONING:** R-2 (Single Family Residential)

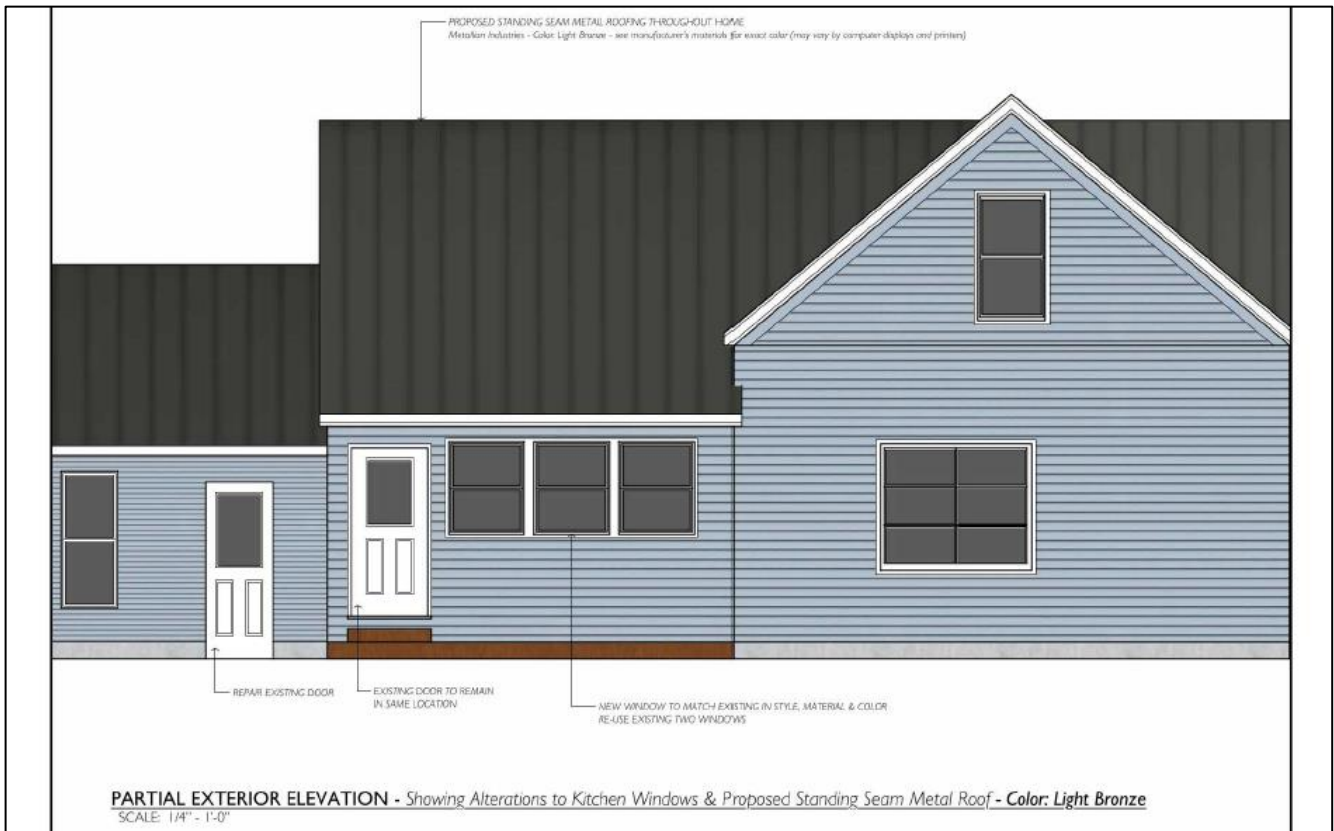
The proposed alterations are identified in the submitted south building elevation below:

Findings for Window Alteration: The specific window alteration involves moving an existing vinyl window slightly, and installing another vinyl window immediately adjacent to it. The existing window will remain, but will be relocated. The addition of a new window in this location is not a replacement of a missing feature, but rather a new feature being installed adjacent to window features that have already been altered and replaced with vinyl window materials.
